The Historical Experience of Scaled-Down Nineteenth Century Drydock Technology

Alan Lemmers

The Northern Mariner/Le Marin du nord, VIII, No. 3 (July 1998), 63-87.

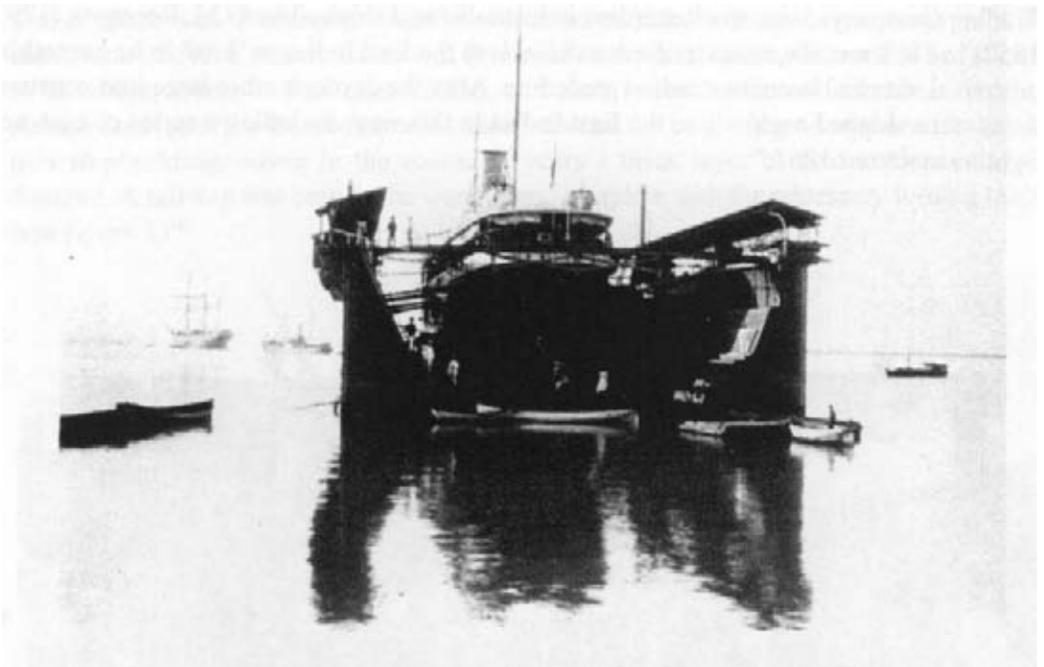
Figure 5: A vessel docked in the drydock in Tandjoeng Priok, Batavia harbour.

Attention should be drawn to the superb performance of the Royal Factory. In the Netherlands the dock had never floated, and there was no tradition or experience for the manufacturers to fall back upon. Nevertheless, without a hitch the dock embarked upon a long and active career. (see figure 5)
