Henry Felix Woods and the Black Sea/Bosphorus Entrance Maritime Safety System, Then and Now

Caroline Finkel

Inventory of Sites of the Black Sea/Bosphorus Entrance Maritime Safety System

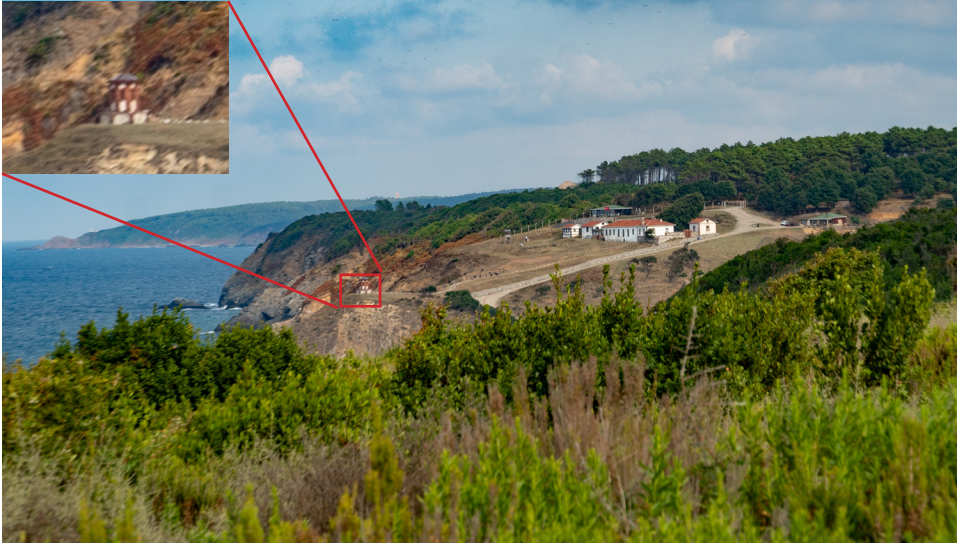
İngiliz evleri, looking east to Karaburun headland

knoll, stood a ruined brick tower (indicated by the arrow in the photograph).³ We had no idea what these structures were, but learnt from local people that the place is today called “İngiliz evleri,” or “English houses.” Back home, we discovered from a Turkish blog that they were part of the network of structures of the Black Sea/Bosphorus entrance maritime safety system established in the late 1860s with the close involvement of the British, and most notably of Navigating Lieutenant Henry Felix Woods, later Admiral Sir Henry Felix Woods Paşa of the Sultan’s navy.⁴ As we continued to hike the coasts on both sides of the Bosphorus, we found other buildings and towers of similar appearance and resolved to investigate their history.

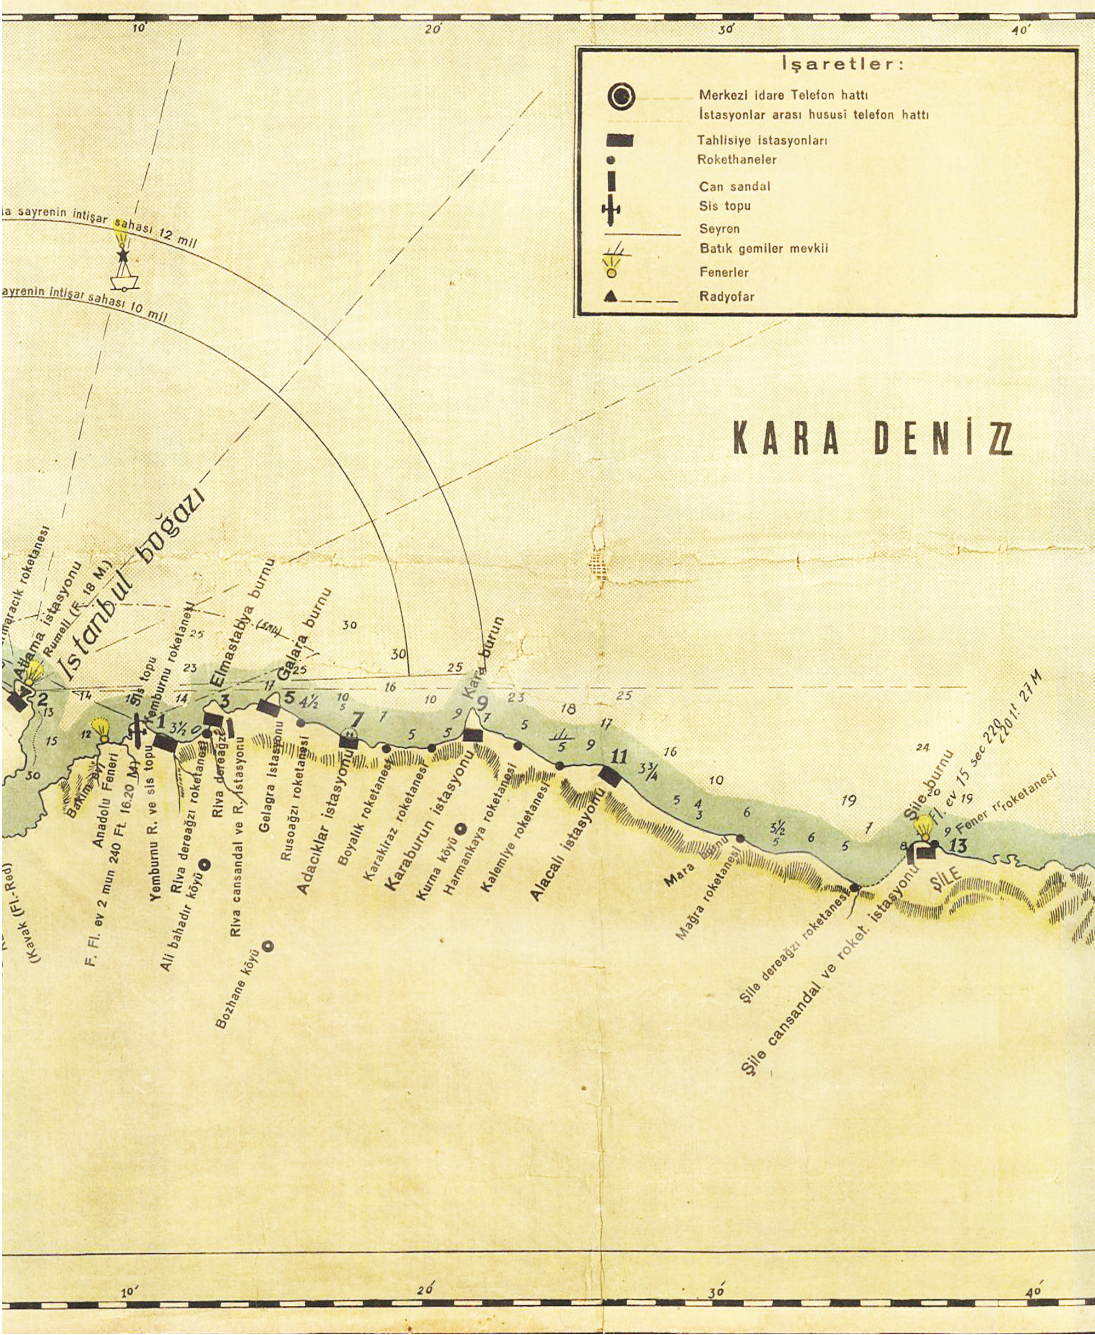
Transport Ministry - General Directorate of State Ports Management - Map Showing Black Sea Rescue Stations

(Münkalat Vekaleti Devlet Limanları İşletme Umum Müdürlüğü Karadeniz Cankurtaran İstasyonlarını Gösterir Haritadır)

The ongoing attention paid by the Ottoman and Turkish authorities to maritime safety in these waters is evident from the map of the rescue stations of the early Republican era (pp. 394-95). It shows the Turkish coastline on either side of the Bosphorus Strait, between Terkos Lagoon in the west and Kefken, beyond Şile, in the east. The map is undated, but written by hand on one of the legends is "1935-1964." We may hazard the assumption that it was current between these dates. The map was printed by the Transport Ministry, General Directorate of State Ports Management (*Münakalat Vekaleti Devlet Limanları İşletme Umum Müdürlüğü*),⁷⁵ and records the facilities of the Black Sea maritime safety system—rocket stations (*rokethanesi*), lifeboat houses (*cansandal kayıkhanesi*), and rescue stations. It shows headlands (*burun*) and rivers (*dere*), as well as depths along the coast and at the Bosphorus mouth, and marks some inland villages. By the time this map became a reference tool, the maritime safety facilities for these waters numbered many more than were conceived of in Woods' scheme.

an increase in the number of coastal sites where facilities of the maritime safety system were positioned. There is a particularly notable increase in the number of rocket batteries, reflecting the fact that this coast remained a significant danger to mariners (see Tables 1&2). Woods' beacons have undoubtedly rusted away—we have not knowingly come across any remnants of them on our hikes. Indeed, no beacons are shown on the map; at some locations, such as Mağara and Alacalı, on the Asian coast, they appear to have been replaced by other facilities.

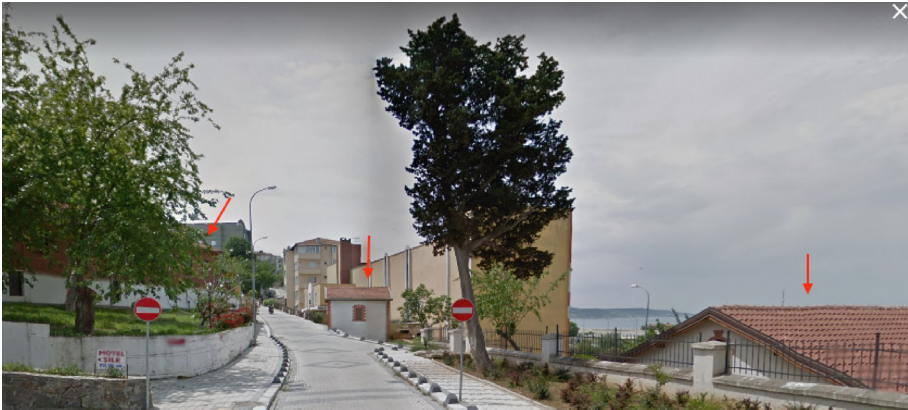
The refuge house is behind the tree on the left; the rocket battery is in the middle and the lifeboat station is below the modern road. (Google Street Map)

Şile's lighthouse (41.177837°, 29.616404°) is on a headland on the east side of the town; the Rescue Stations map shows a rocket battery nearby. The Şile station today comprises the refuge house, rocket battery and lifeboat station, which are 500m west of the lighthouse. They are now far inland owing to infilling of the coast, on Plajyolu Sokağı. The refuge house is being restored for current use. A watch tower was also recorded here in 1999.¹

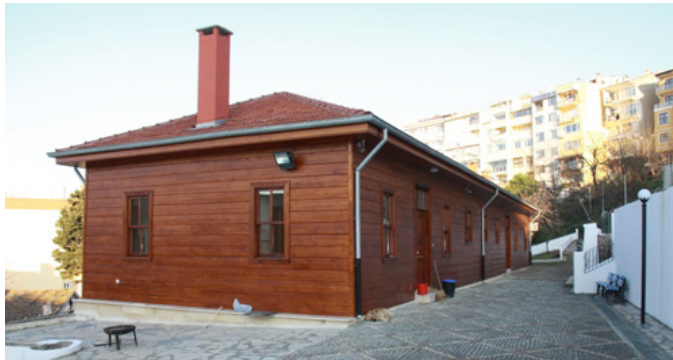
Refuge house (<https://www.gidilmeli.com/Tahlisiye-binalari-sile/10841/1>)

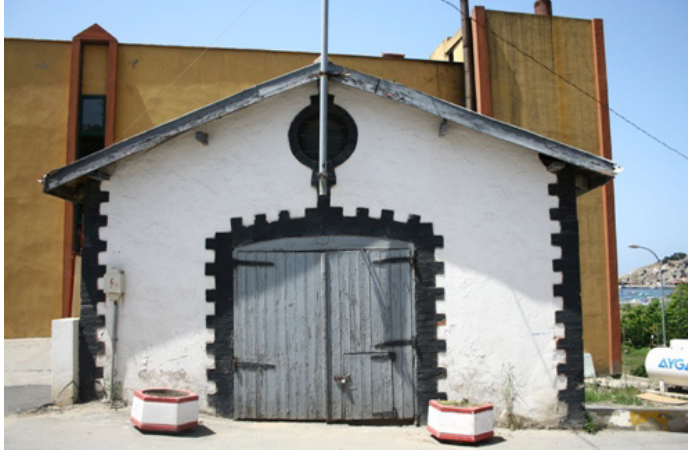
Rocket battery (<https://www.gidilmeli.com/Tahlisiye-binalari-sile/10841/1>)

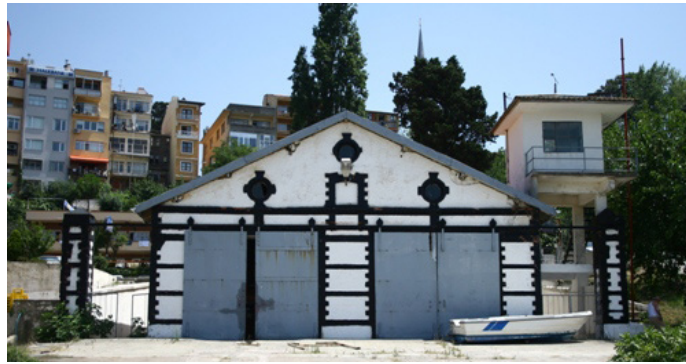
Lifeboat station (<https://www.gidilmeli.com/Tahlisiye-binalari-sile/10841/>)

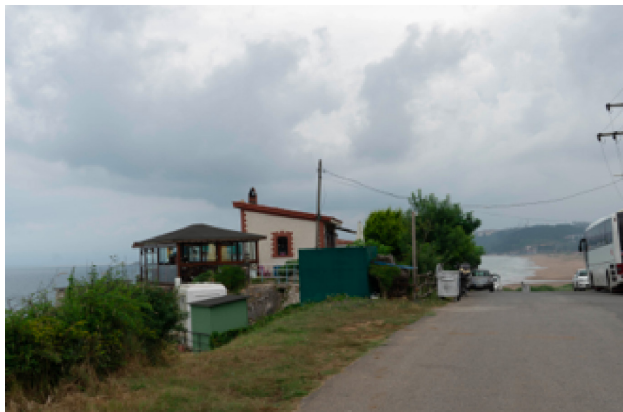
Rocket battery (photo: OG)

A rocket battery (41.172778°, 29.567357°) is shown here on the Rescue Stations map. Situated high above the beach, it is today a restaurant that acknowledges the historic past of the building with information panels describing the part that rockets played in saving the crews of shipwrecked vessels.

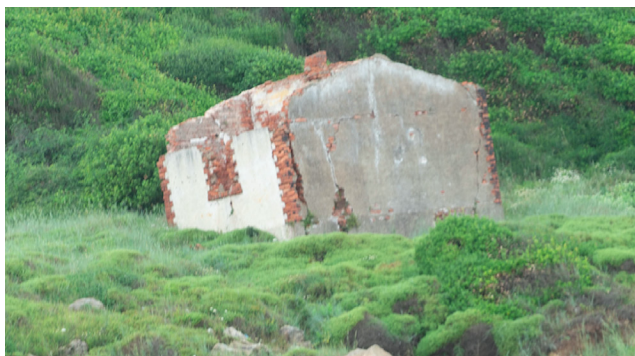
The rocket battery (41.184284°, 29.512765°) marked on the Rescue Stations map is situated some metres above the beach. The name Mağara means “cave” in Turkish, and denotes the so-called Xenophon’s Cave nearby.

Rocket battery

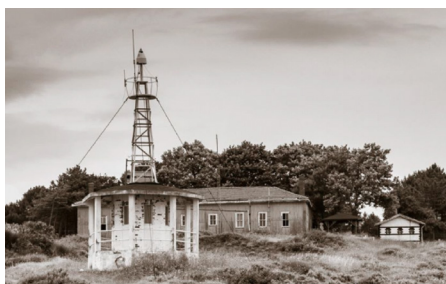
A station is marked on this prominent headland on the Rescue Stations map. In 1999, the complex included a refuge house, a watch tower—since repurposed as a light—and a rocket battery.³ The lifeboat house (41.213894°, 29.389427°) is on the shore below. On 19 December 2018 a cargo ship sailing under the Comorian flag ran aground (41.215724°, 29.387382°) in heavy seas at this “False Bosphorus.” Its crew were rescued by the local coastguard; the ship’s hulk remains where it came to rest.

Watch tower base with refuge house behind

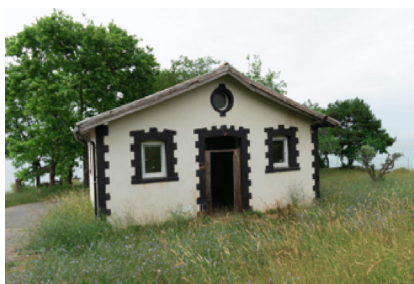
Rocket battery

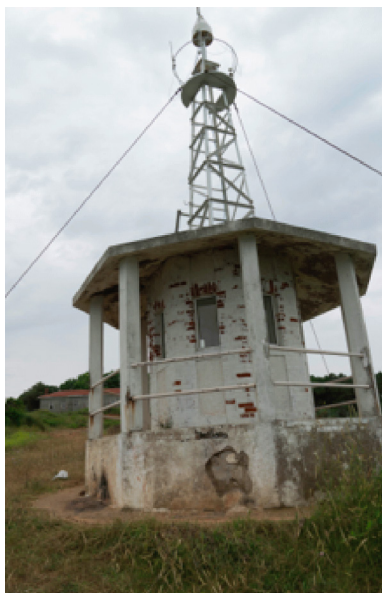
Watch tower base

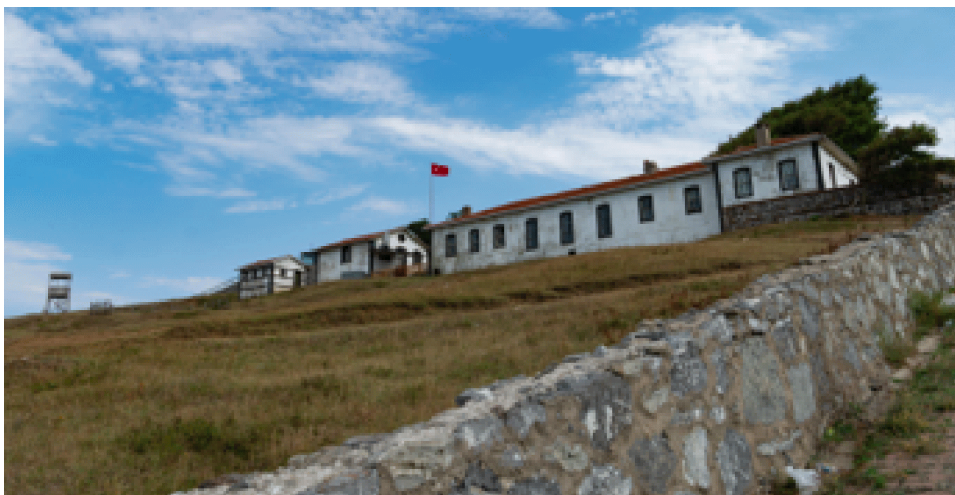
Adacıklar station

Adacıklar station is well preserved; it attracts local tourists and is used as a film set. It has not been possible for us to distinguish the different structures that make up the complex, apart from the watch tower (41.221804°, 29.297037°), which has been reroofed since we first saw it some years ago.

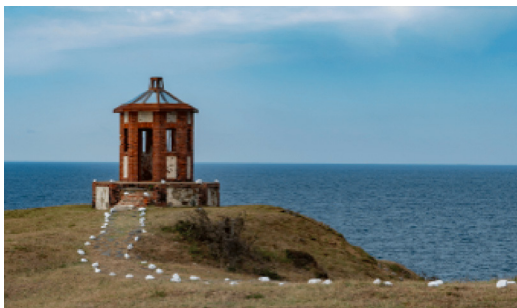
Restored watch tower

We have noted that watch towers are not mentioned as elements of the maritime safety system by Woods, nor marked on the Rescue Stations map. Some, at least, of the bricks used to build the Adacıklar watch tower are stamped on their visible face with the design of a star between two opposing crescents, with a pair of round discs outside each crescent, and acanthus leaves partly encircling these on each side of the brick, with a third acanthus leaf below. The other face of the bricks is hidden. This motif is that of Salomon Brick Factory in the Büyükdere suburb of Istanbul, on the European shore of the Upper Bosphorus.

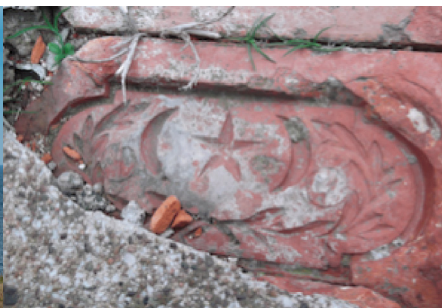
Watch tower brick with Salomon Brick Factory stamp.

The Salomon factory is thought to have begun production later than 1869,⁴ when Woods carried out his work, but further research is needed to provide a more precise date. Once in possession of this information, and assuming the bricks are from the original structure, we will be able to suggest when the watch towers were built.

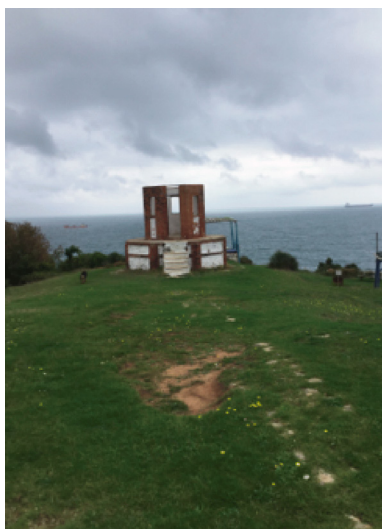
A station is marked on this prominent headland on the Rescue Stations map; there is also a watch tower (41.233186°, 29.253838°). Today the site is used as a cafe/picnic place.

Watch tower

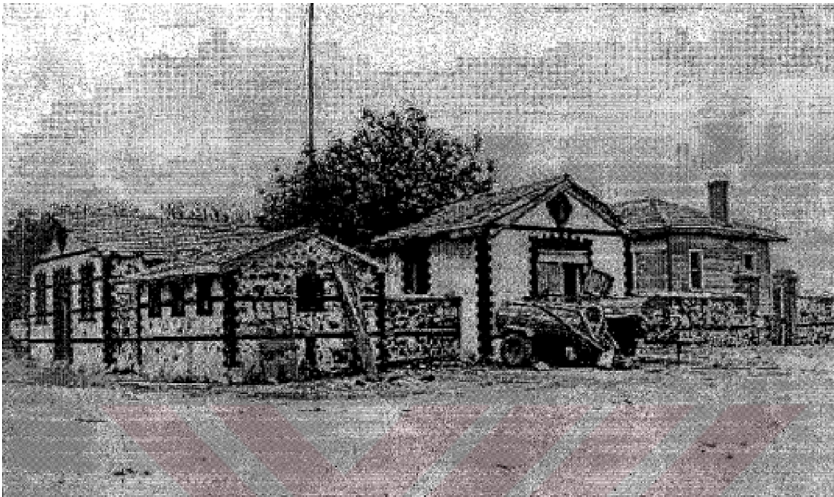
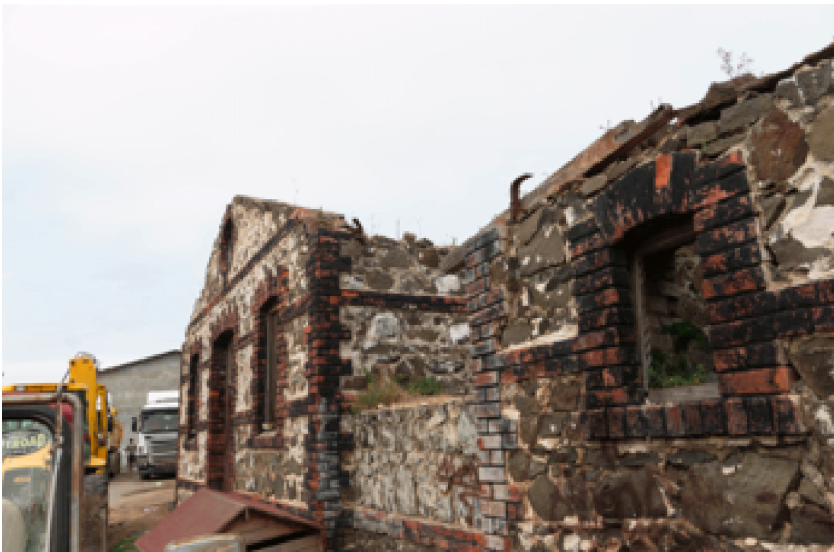
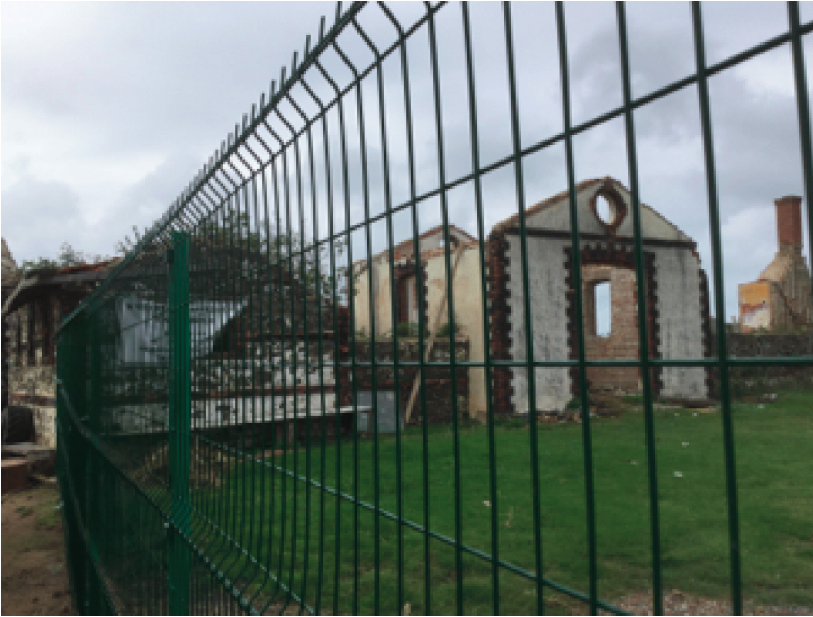
Woods mentions a rocket battery at Riva and the Rescue Stations map also indicates a lifeboat house. The complex here (41.227996° , 29.223026°) is perhaps the most extensive on this coast and, unlike others, has a wall all around. Yet like the watch tower, it is not mentioned in these sources. The several extant structures at Riva include a refuge house, a rocket battery, stables—stables were also found at other rescue stations—a watch tower, and a dilapidated timber clad mansion.

The watch tower at Riva station is built into the wall of the enclosure and is a mightier structure than the free standing ones we have seen elsewhere. This complex has been left to decay, despite proposals for its rehabilitation and reuse.⁵

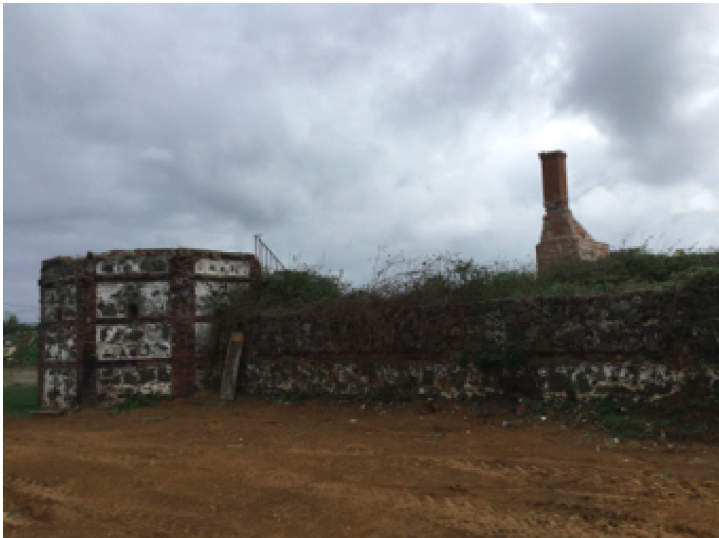
Watch tower base, with chimney of mansion within the walled enclosure

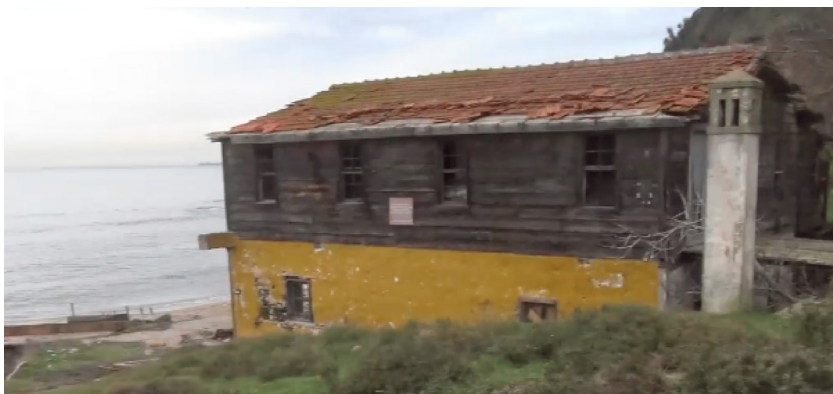
Yomburnu/Kabakoz Bay lifeboat house (<https://vimeo.com/312029924>)

The complex is marked on the Rescue Stations map as a station, and in 1999 included a mansion, a refuge house, a watch tower, stables and a rocket battery.⁶ It is within a military base atop the cliff. The lifeboat house (41.218099°, 29.162888°) is on the shore below, in Kabakoz Bay.

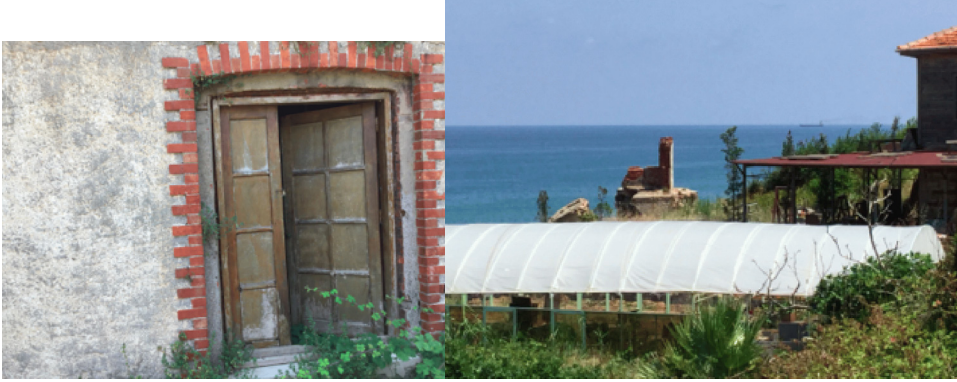
Detail of an entrance (photo: CF)

View of Kısırkaya watch tower (photo: CF)

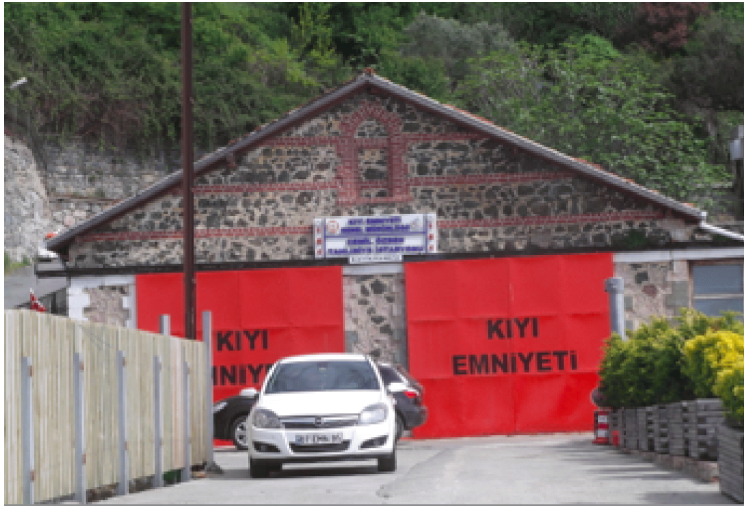
Kumköy is a now little used name of Kilyos. Its lifeboat house (41.247671°, 29.034754°) is in the small port.

Kumköy/Kilyos lifeboat house (photo: CF)

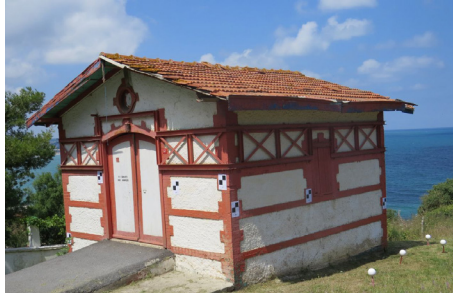
Restored rocket battery

included a refuge house, a rocket battery and a watch tower.⁹ The rocket battery has recently been restored.

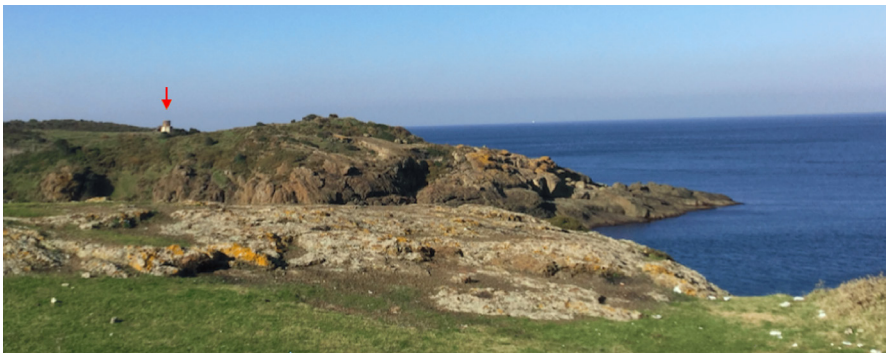
This isolated watch tower, (41.239478° , 29.104262°), whose name we do not know, stands some 800m northeast of Rumeli Feneri village.

View of watch tower from the east

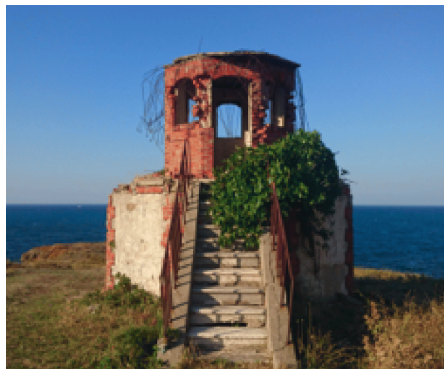
Watch tower (photo: OG)

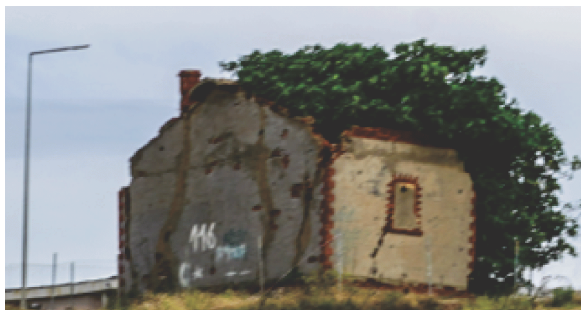
During editing of this article we came upon another structure (41.245258°, 29.012456°) between Kilyos and Kısırkaya on the European side. According to the Rescue Stations map, it seems to be the Tatlı su roketanesi (Tatlı Su [Engl. sweet water] rocket battery); the name 'Tatlı su' implies there is a spring or stream nearby, which is confirmed on Google Earth.
